TURBO AFTERMARKET Service Bulletin

New Retrofit Actuator for Ford V2S and HP Turbos

TURBO AFTERMARKET
**Service
Bulletin**

6.4 liter V2S and HP stage Actuator Replacement

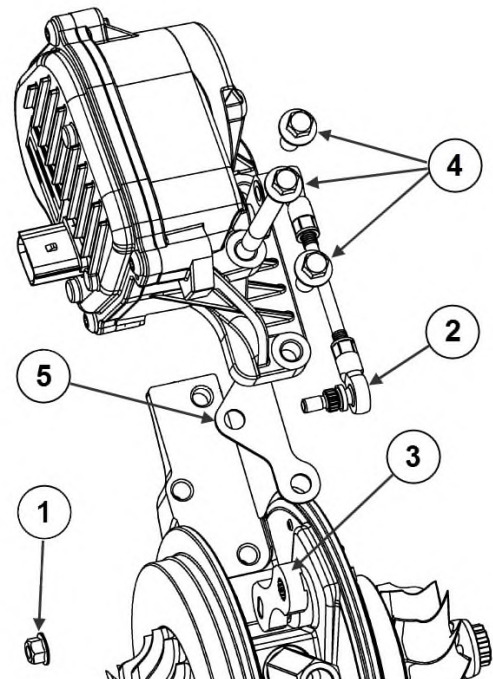
See *Figure 1*

1. Remove M6 nut (1) and separate linkage (2) from dog-bone (3)
2. Disconnect two coolant hoses from SRA
3. Disconnect electrical connector from SRA
4. Remove three M8 bolts (4)
5. Remove SRA Assembly and thermal spacer (5) from turbocharger
6. Properly discard SRA Assembly and hardware

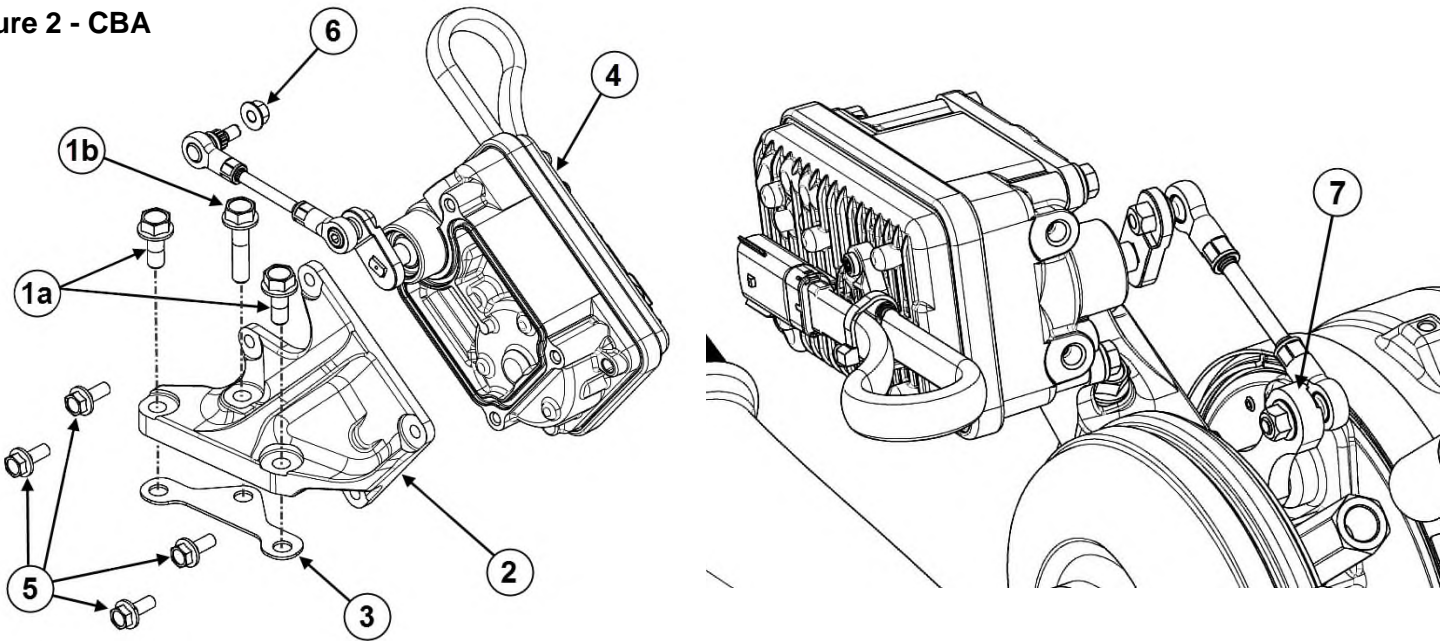
Figure 2 - CBA

1. Mount the thermal spacer (3) and Actuator bracket (2) to the turbocharger bearing housing using the supplied M8 bolts (1a,1b), ensuring proper orientation of thermal spacer. Torque the three M8 bolts to 19±1 Nm.
2. Insert Actuator linkage end into dog-bone (7) and loosely secure with M6 nut (6) by hand
3. Install Actuator assembly (4) to bracket (2) using the four supplied M6 bolts (5) and tighten to 13.5±1.1 Nm
4. Tighten M6 nut (6) to 10.5±0.3 Nm

See Figure 2

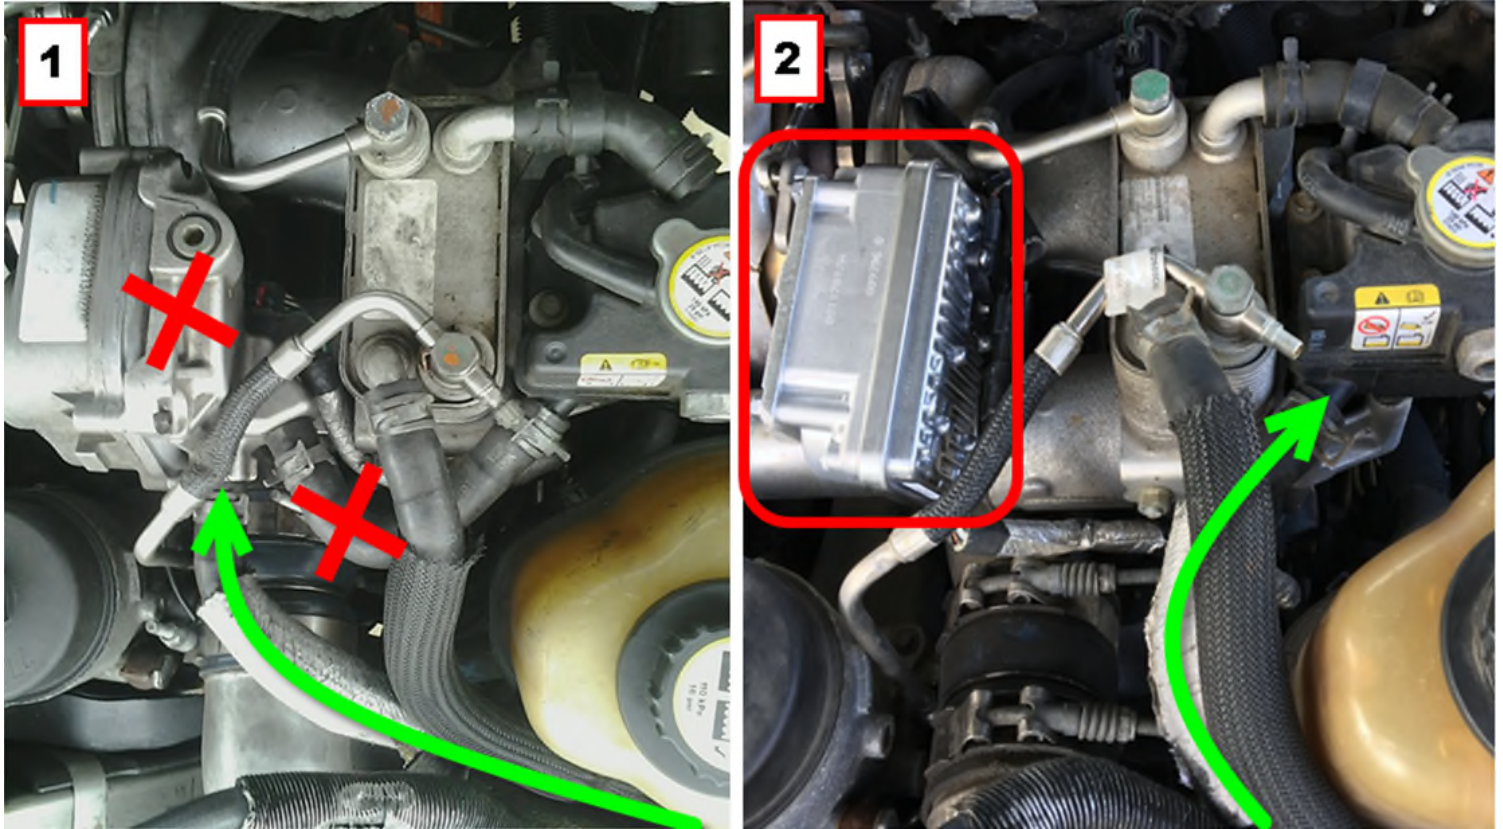
Photo #1 below shows the original actuator and coolant line arrangement and Photo #2 shows the new actuator with the coolant line rerouted directly to the coolant reservoir.

The coolant block attached to the original SRA actuator and the short hose connecting the coolant block to the reservoir will no longer be used. See red **X**'s in photo #1 above.

The shielded hose marked with the green

will move from the coolant block connection shown in photo #1 and go directly to the reservoir connection as shown in photo #2.

The new CBA retrofit actuator does not require water cooling as did the original SRA. The existing coolant lines can be rerouted to bypass the actuator and complete the cooling circuit without modification by eliminating the actuator coolant block and the short hose that went from the old actuator coolant block to the reservoir.
