Performance Turbo Resonator Kit

Part Number: 17-131

Installation Instructions

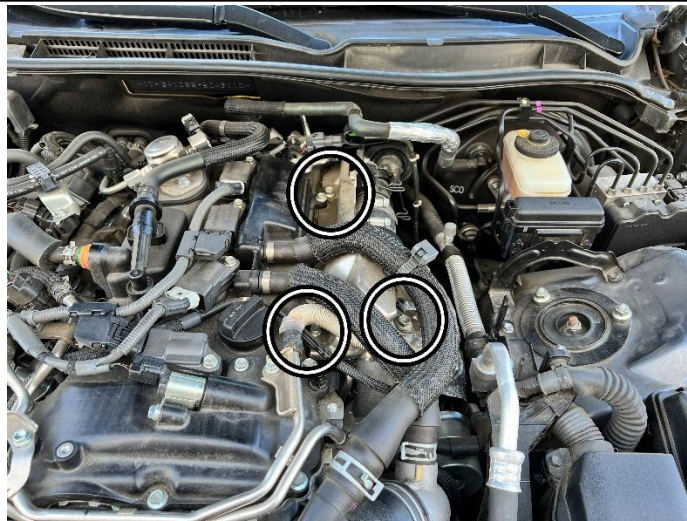
7. Remove the 3 bolts (2x 12mm, 1x 10mm) securing the heat shield.

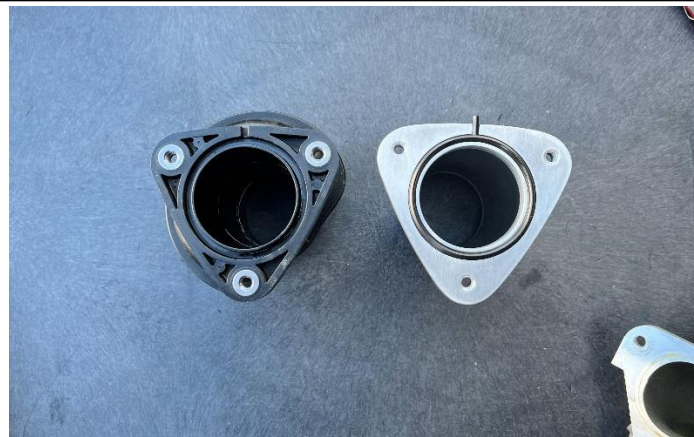
14. Remove the factory O-ring from the resonator and transfer it onto the HPS Resonator Delete.

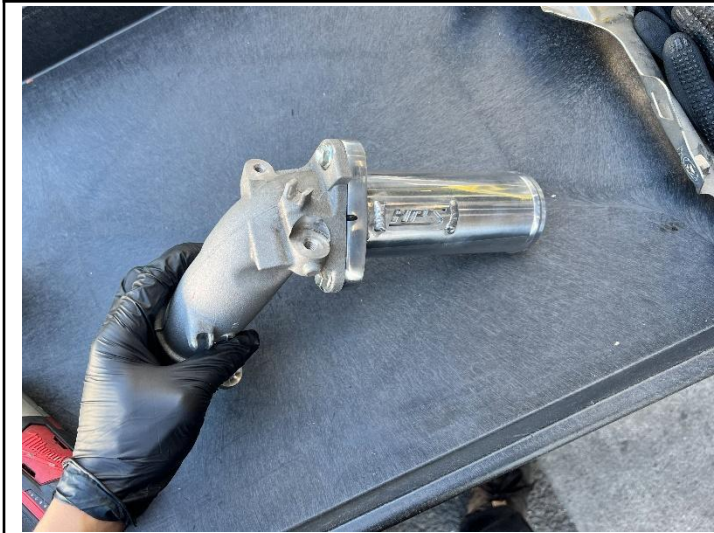
15. Secure the HPS Resonator Delete onto the turbo outlet elbow using the factory bolts. Torque to 8 ft-lb.

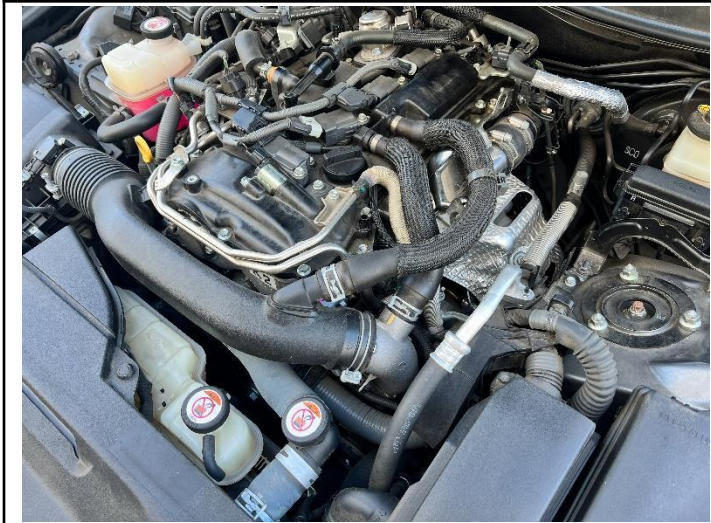
18. Reinstall the heat shield back into the vehicle and reconnect the breather hoses. Clip the vacuum hose back onto the turbo outlet elbow.

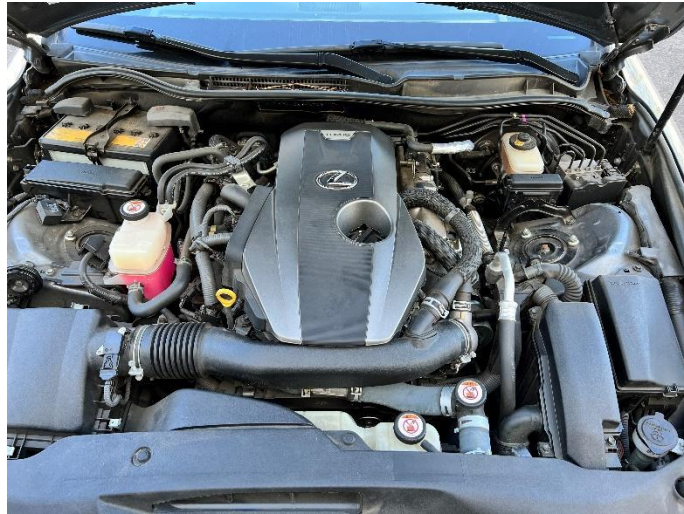
19. Reinstall the engine cover back onto the vehicle.
