3" Side Bar

Part No. 1150530071/3

Fits: 2007 - 2017

Toyota Tundra Regular Cab

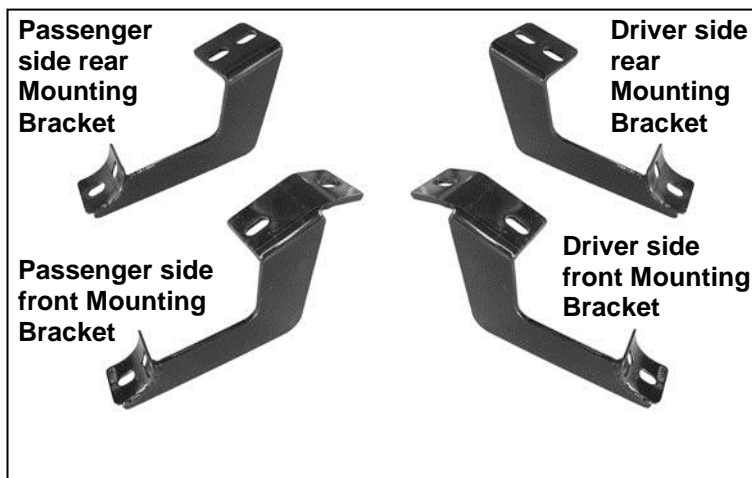
PARTS LIST:

Qty	Part Description	Qty	Part Description
1	Driver/Left Front Mounting Bracket	16	8-1.25mm x 30mm Hex Head Bolts
1	Passenger/Right Front Mounting Bracket	16	8mm Lock Washers
1	Driver/Left Rear Mounting Bracket	16	8mm ID x 24mm OD x 2mm Flat Washers
1	Passenger/Right Rear Mounting Bracket

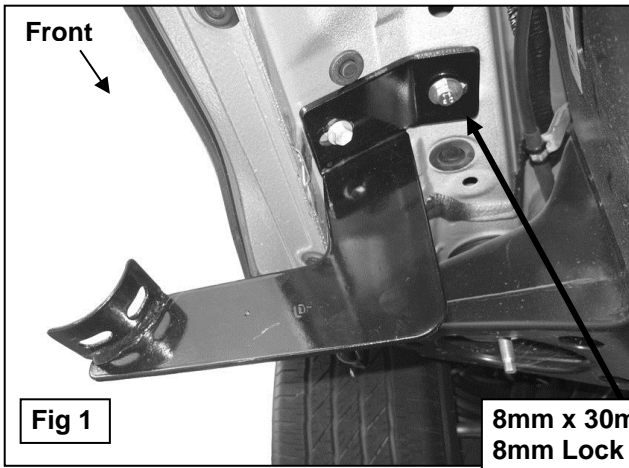
- Starting on the driver side front of the vehicle, remove the (2) plastic plugs or factory hex bolts to uncover the threaded holes used to install the front Mounting Bracket. Partially attach the driver side front Mounting Bracket to the vehicle using the included (2) 8mm x 30mm Hex Head Bolts, (2) 8mm Lock Washers, and (2) 8mm Flat Washers, (Figure 2). Do not tighten hardware at this time.

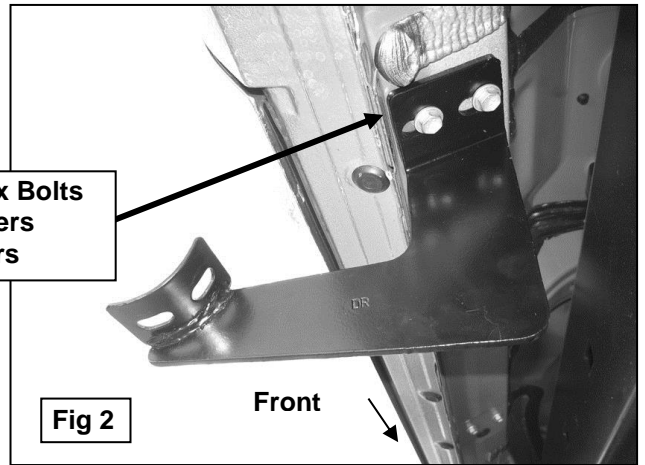
Remove the (2) plastic plugs or factory hex bolts to uncover the threaded holes in each mounting location.

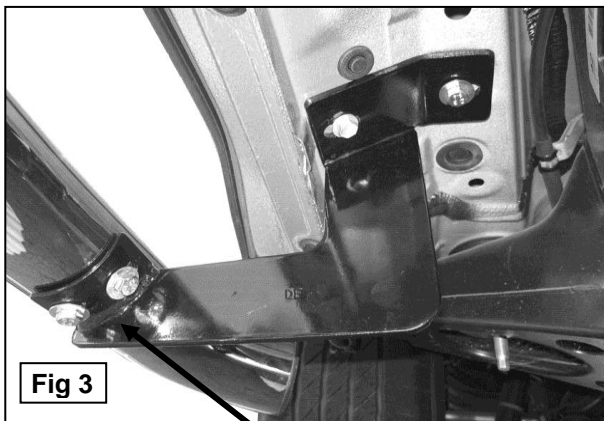
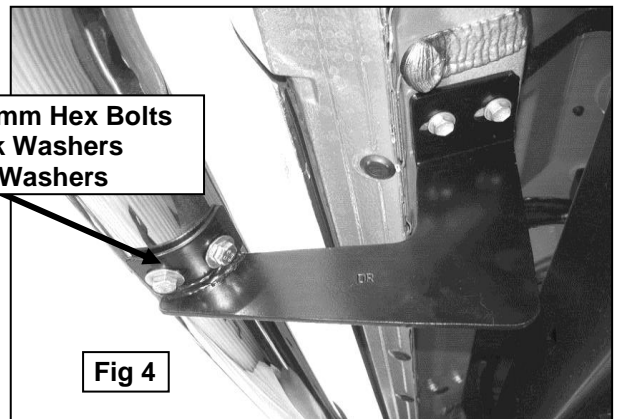
2. Repeat Step 2 to attach the rear Mounting Bracket to the vehicle.
3. Align the holes on the bottom of the Side Bar with the holes on the Mounting Brackets. Attach the Side Bar to the Mounting Brackets with the included (4) 8-1.25mm x 30mm Hex Head Bolts, (4) 8mm Flat Washers, and (4) 8mm Lock Washers, (**Figure 4**). Do not tighten at this time.

8mm x 30mm Hex Bolts
8mm Lock Washers
8mm Flat Washers

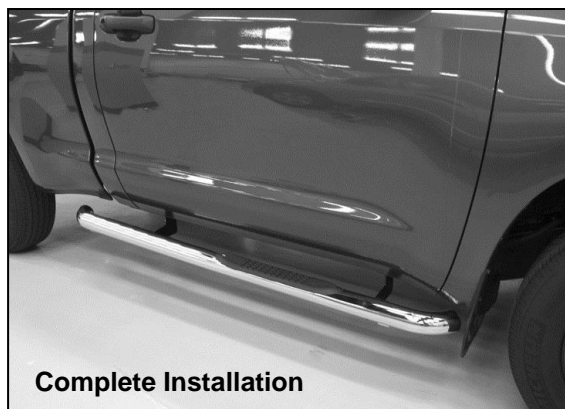
Complete Installation

4. Level and adjust Side Bar properly and tighten all hardware
5. Repeat Steps 1-4 for passenger Sidebar installation.

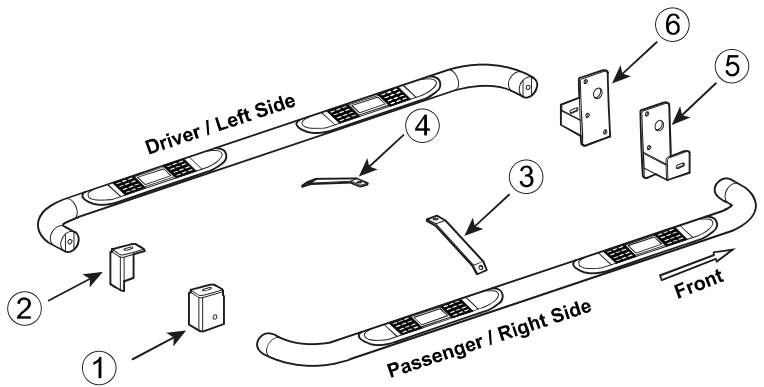
PARTS IDENTIFICATION GUIDE

Driver Side tube packed using "Green" color foam sheet. Passenger Side tube packed using "White" color foam sheet

No.	Parts Identification
1	Passenger / Right 'Rear' Bracket marked "PR"
2	Driver / Left 'Rear' Bracket marked "DR"
3	Passenger / Right 'Center' Bracket marked "PC"
4	Driver / Left 'Center' Bracket marked "DC"
5	Passenger / Right 'Front' Bracket marked "PF"
6	Driver / Left 'Front' Bracket marked "DF"

- 2. Mounting Bracket are not getting Installed properly.**
In some cases Illustration images shown in Installation manual may not be the exactly same as per actual vehicle images ,also if Driver / Passenger side mounting brackets are very identical in the design, suggest referring Parts Identification guide to avoid fitment issue.

- 4. Side Bar is not aligning with vehicle / Step Pads are not aligning with vehicle doors.**
Side bar may be interchanged or mounting brackets are not installed at the correct position in the vehicle. Refer Parts identification guide.
