TSB-167

Concentric Slave Cylinders

To prevent a Concentric Slave Cylinder (CSC) from failing or being damaged it is important that you follow the simple guidelines whilst handling and/or fitting the slave to the vehicle.

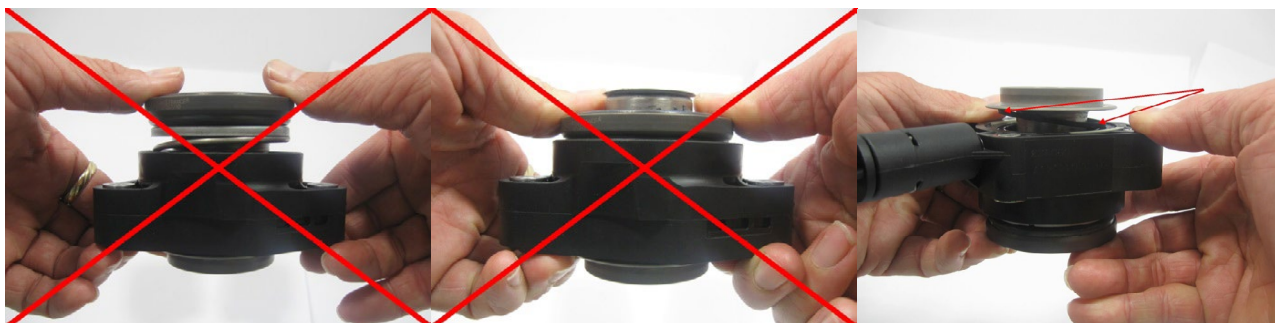
Every CSC is different so it is important to never depress the slave cylinder by hand prior to fitting to a vehicle. This can dislodge the seals in the back of the slave without being noticed. As a result the slave may leak once installed.

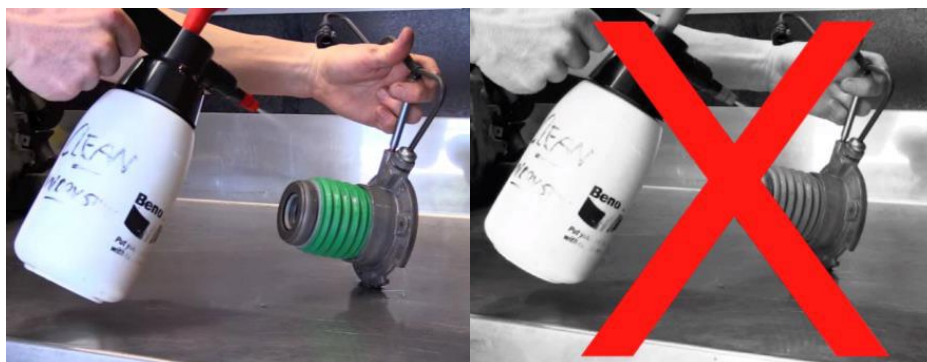
Never spray brake cleaner or solvents in or around the CSC. This can cause the seals to swell and wash away the assembly lubricant.

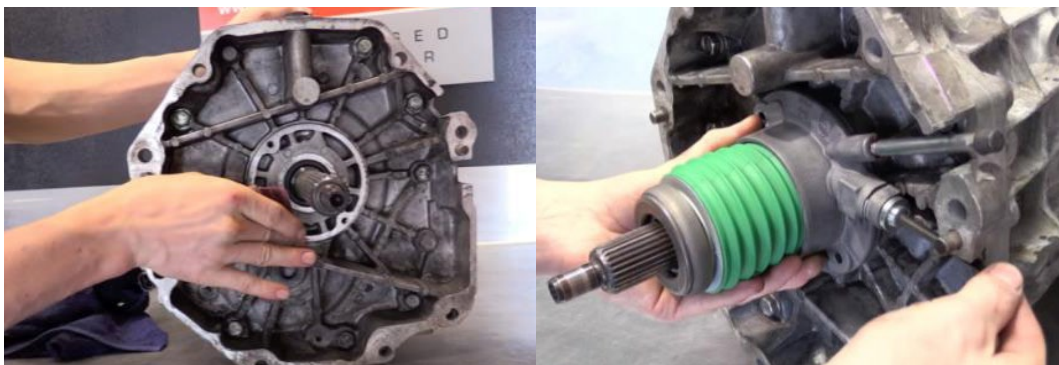
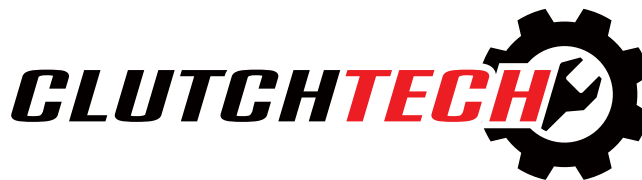
Check the supply pipes to the CSC, if damaged, blocked or fatigued the pipes will need to be replaced. Clean and check the mounting surface of the CSC on the transmission. Replace gaskets, seals or sealing compounds as per the manufacturers specifications. The mounting surface needs to be free of dirt and contaminants along with ensuring there are no burrs or corrosion on the machined surface. Carefully mount the CSC on the transmission and check that it fits square on the mounting surface. Also ensure that the pipes do not foul on the transmission.

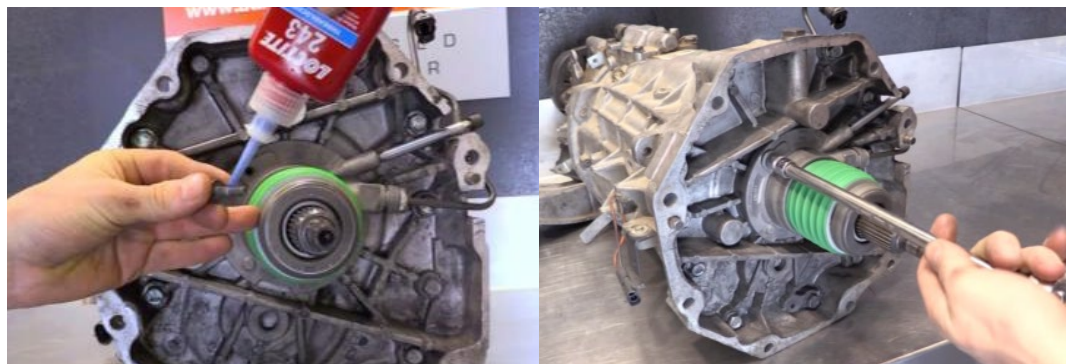
Use thread locking compound on the mounting bolts and torque to the manufacturers specifications.

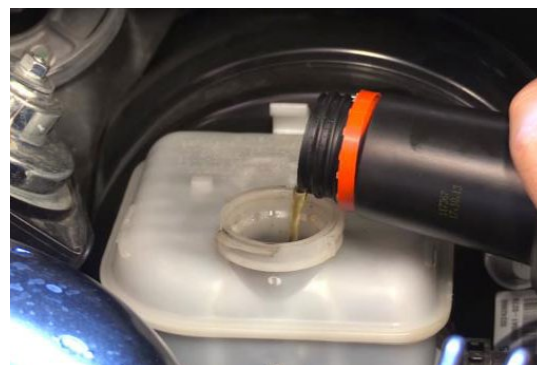
When fitting a new Concentric Slave Cylinder (CSC) it is important to take great care bleeding the hydraulic clutch system. Over pressurizing the concentric slave cylinder can cause the cylinder to fail. Please follow the manufacture's recommended manual bleeding procedure. Where there is no procedure specified, follow the process below:

- 1) Fill the reservoir with the applicable clutch fluid to the manufacture's specifications.
- 2) Open the bleeder nipple on the braided bleeder line and have someone in the vehicle slowly depress the pedal to the floor by hand. Close the nipple and return the pedal to the top. Repeat the process of passing the fluid through 4-5 times.
- 3) Change the process to slowly depressing the pedal to $\frac{3}{4}$ stroke and holding by hand before opening the bleed nipple. Lock the bleed nipple and return the pedal to the top. Repeat this 4-5 times whilst maintaining the fluid level in the reservoir.
- 4) Check that the clutch has full release and the pedal is not spongy. If the pedal is still not satisfactory repeat step 3 using a full pedal travel.

Notes: Never rapidly pump the pedal when bleeding. This can induce air in the system. Slow steady pumps of the pedal are much more effective. Extra caution should be taken when bleeding the clutch when installing a self-adjusting pressure plate.

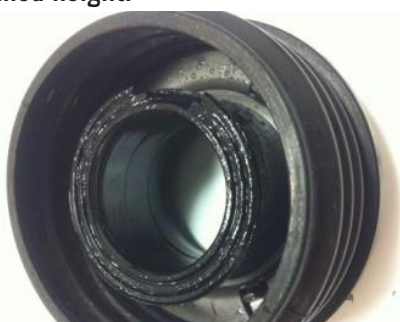
Damaged Seal

If a piston is over stroking this can cause damage to the end of the guide tube or even to the piston seals. Over stroking can be caused by several things such as, incorrect pedal adjustment or incorrect clutch fitment causing low installed height.

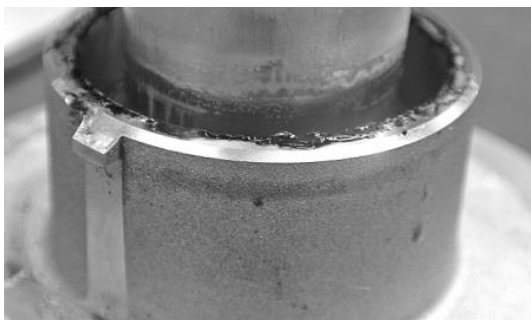
Deteriorated Seals

Whenever a hose/ pipe is disconnected from the slave cylinder, ensure that the seal/ O-ring has come out too and inspect it carefully. If the seal is swollen or damaged it will need to be replaced. Damaged seals can cause leaks or deteriorate and induce blockages in the slave cylinder or lines resulting in a hard pedal.

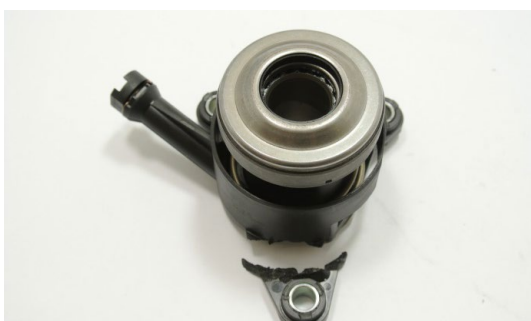
Broken Tab

Mounting a CSC off axis, incorrect bolt torque or bolt quantity can cause several problems. This can cause the CSC to leak or have a staging pedal. The indicators are broken tabs or inconsistent wear on the guide tube
