Performance Silicone Air Intake Kit

Part Number: 57-2126

2016-2023 Toyota Tacoma 3.5L V6
(with TRD Performance Upper Airbox)

Installation Instructions

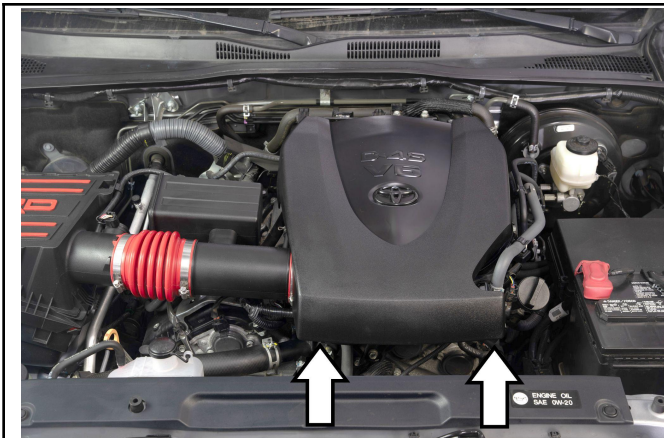
1. Turn the ignition OFF and disconnect the vehicle's negative battery cable. If the engine has run within the past two hours let it cool down.

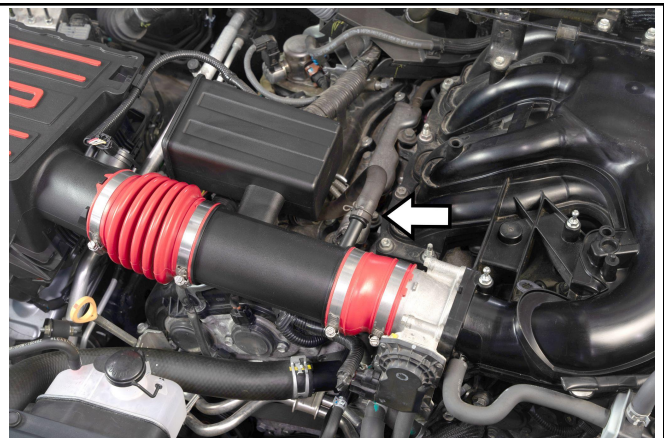
2. Lift and remove the engine cover from the vehicle.

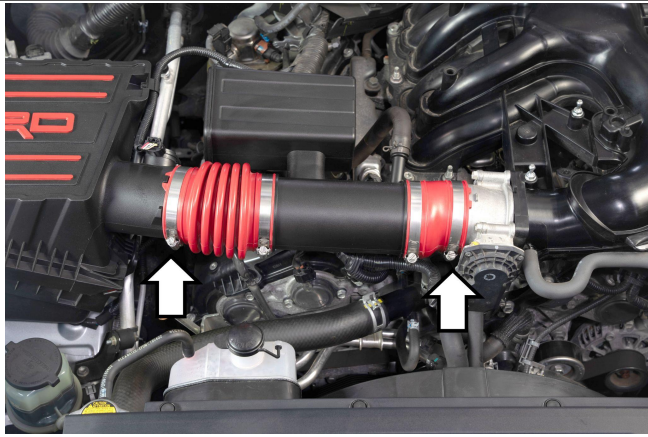
3. Disconnect the breather hose from the intake tube.

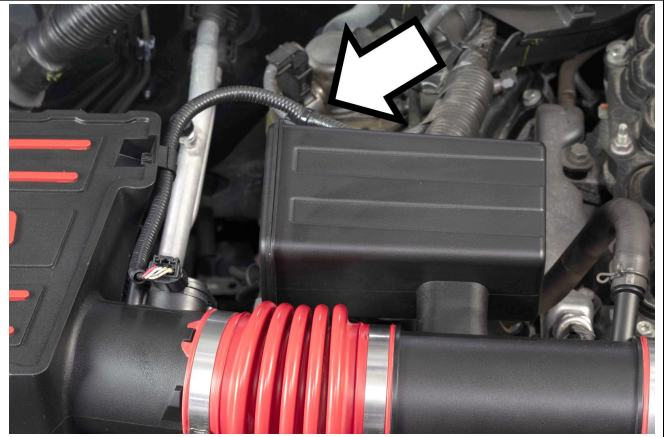
4. Loosen the hose clamps on the throttle body and the air box.

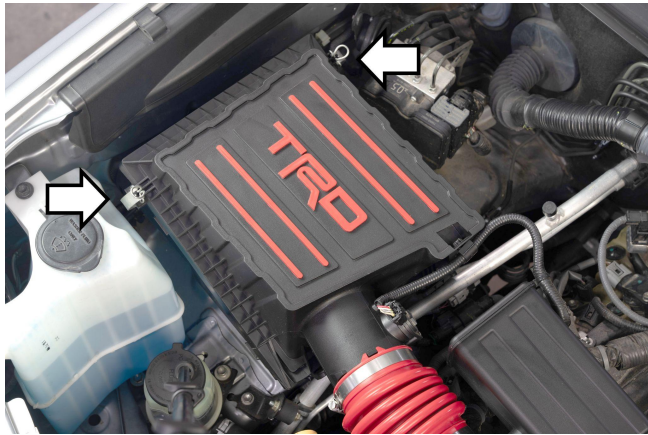
5. Unclip the electrical harness from the resonator.

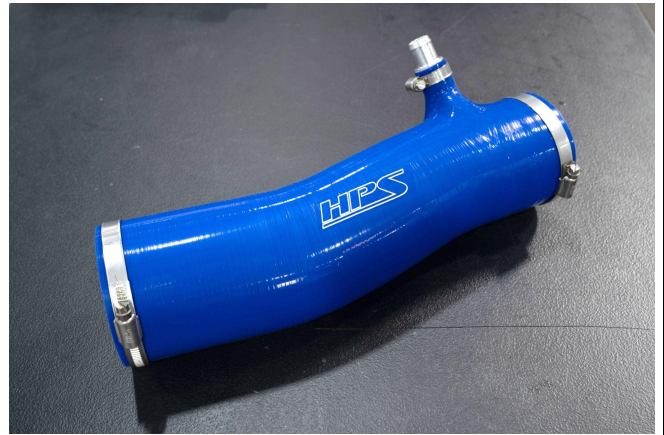
6. Unbuckle the 2 clips securing the upper air box then remove the original intake tube assembly from the vehicle.

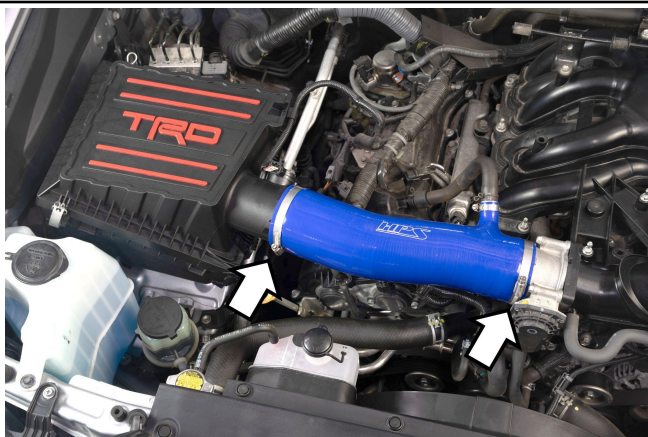
7. Install the provided hose clamps onto the HPS silicone intake tube. Tighten the clamp on the breather nipple to secure the barbed fitting.

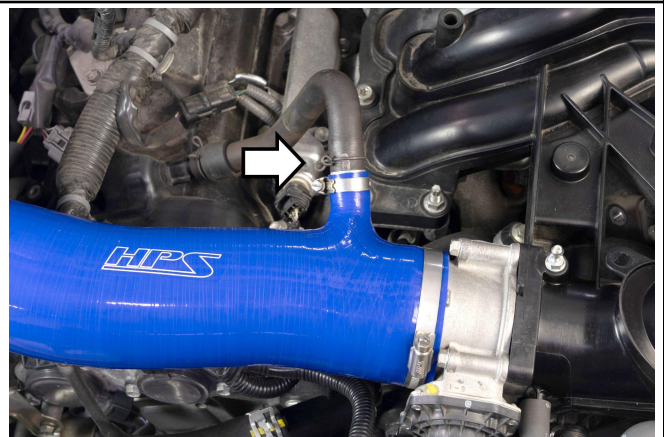
8. Insert the HPS intake onto the air box side first then onto the throttle body side and clip the air box back into place. Adjust the intake tube to the desired position and secure the hose clamps.

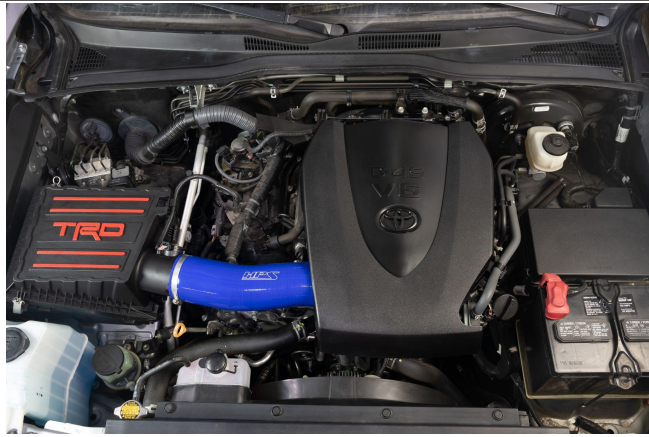
9. Reinstall the breather hose onto the HPS intake.

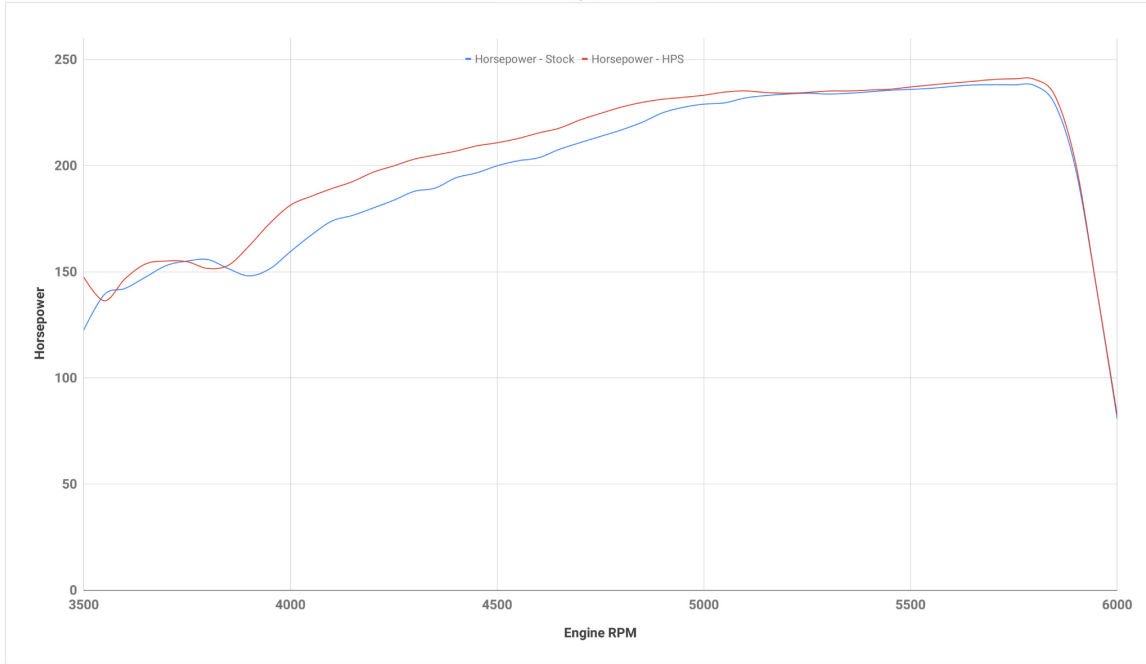
HPS Performance Silicone Air Intake Tube
2016-2022 Toyota Tacoma 3.5L V6 with TRD Upper Airbox
Part Number: 57-2126

Maximum Horsepower Gains = 21.9 whp @ 4000 rpm

Tested Vehicle: 2017 Toyota Tacoma 3.5L V6

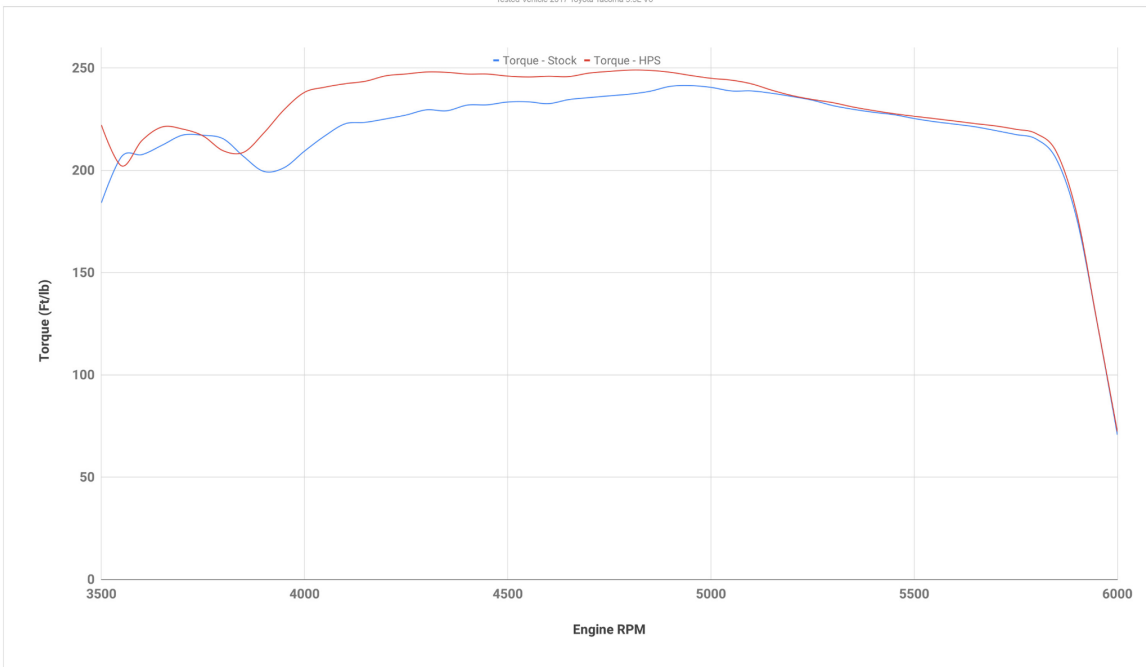
HPS Performance Silicone Air Intake Tube
2016-2022 Toyota Tacoma 3.5L V6 with TRD Upper Airbox
Part Number: 57-2126

Maximum Torque Gains = 28.8 ft/lb @ 4000 rpm

Tested Vehicle: 2017 Toyota Tacoma 3.5L V6
