Performance Strut Tower Bar Part Number: 42-104

2018-2022 Honda Accord 1.5L Turbo 2018-2022 Honda Accord 2.0L Turbo

Installation Instructions

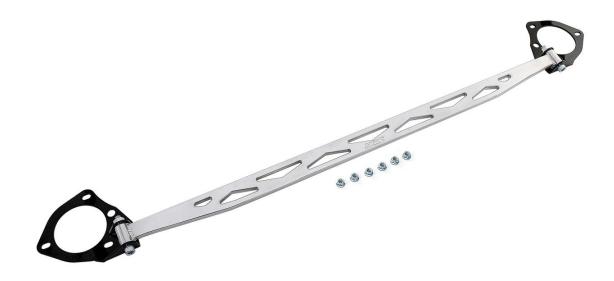
Line #	Description	Part Number	Qty
1	Center Aluminum Strut Bar	451-104-AL	1
2	Left Strut Bar Bracket	431-104-L	1
3	Right Strut Bar Bracket	431-104-R	1
4	Flange Nut, M10 x 1.25mm	95003A216	6

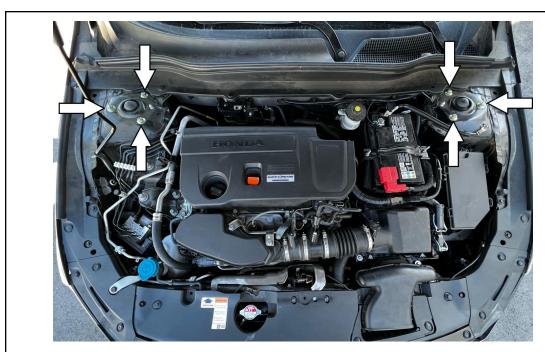
2. Remove the (6) stock strut tower nuts.

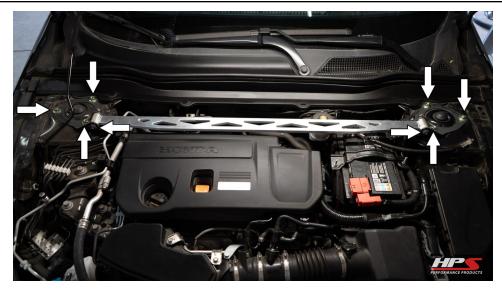
3. Install the strut bar assembly using the provided (6) M10 flange nuts. Tighten the preinstalled nuts and bolts holding the strut bar and the strut bar brackets together.
